ILLUMINATING
HOME INSPECTIONS

Home Inspection Report

LOCATED AT:
1234 Sample Rd
Mountianburg, AR

INSPECTED ON:
Sunday, April 9, 2023

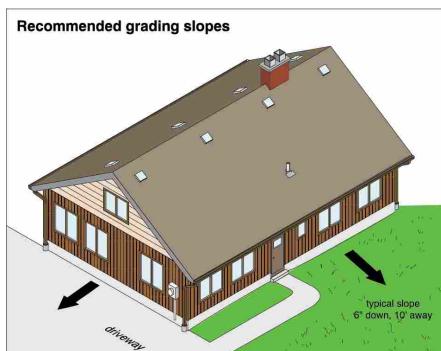
Sloped towards house

Satisfactory
Typical cracks
Pitched towards home

MON Recommend sealing gaps and cracks at driveway to keep water from getting underneath which can cause lift or sink.

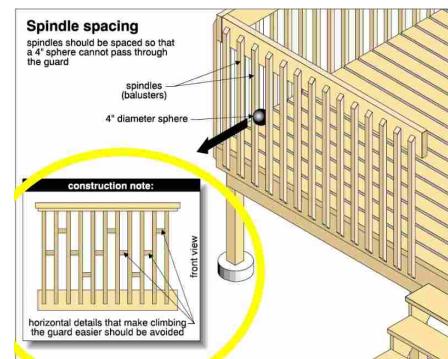
Climable

SAFT The railing is climbable and should have spindles instead so that a small child can't climb over and fall, recommend repair.

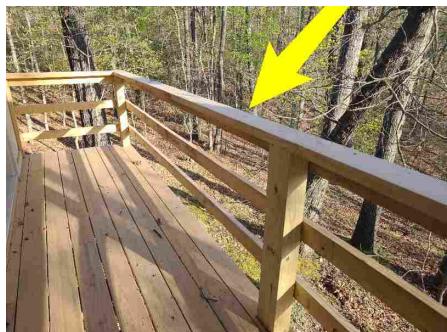
Loose railing

SAFT Deck railing loose, recommend bracing.

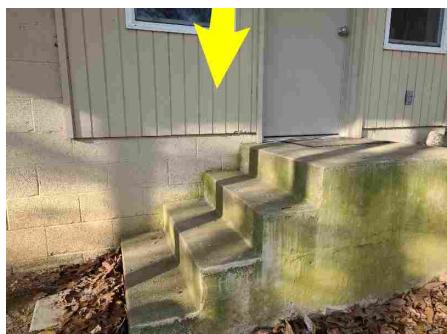
Recommend hand rail

SAFT Hand rails are recommended when there are 3 steps or more.

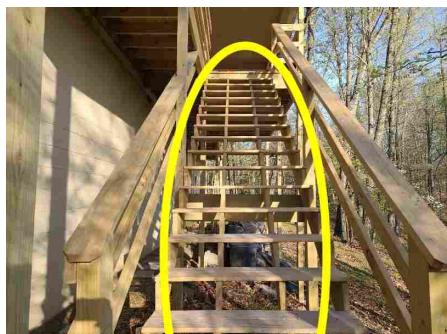
No risers , safety hazard

SAFT Recommend risers, small children and pets could squeeze between steps

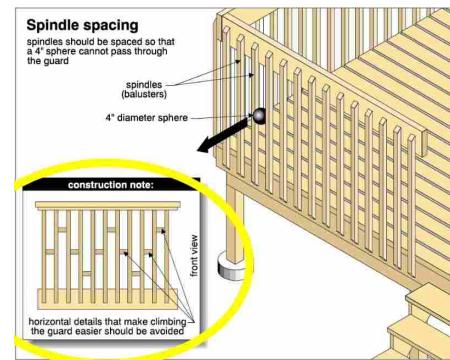
Climable railing. Safety hazard

The railing is loose, recommend additional bracing.

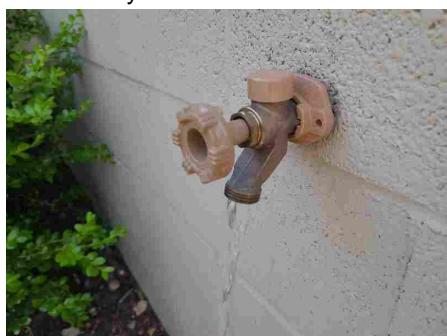
Loose / leaks in crawl , north

North hose / pipe split/dripping, recommend licensed plumber repair

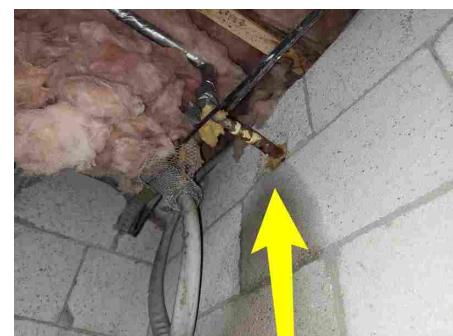
Pipe split in crawl

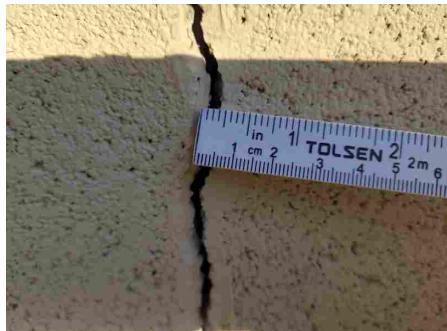
East

Several steps cracks and block cracks

Active cracks with sharp edges are noted as a potential major defect because they indicate a failure in progress and a situation that could grow worse, recommend further evaluation by a structural engineer and/or foundation specialist.
Foundation not fully visible.

Recommend further evaluation by a foundation specialist.

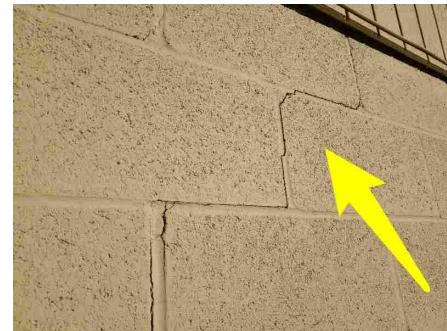
East, step cracks

Cracks less than 1/4 wide should be patched with mortar, epoxy or similar material and monitored, if they become wider, you should consult with a foundation specialist.

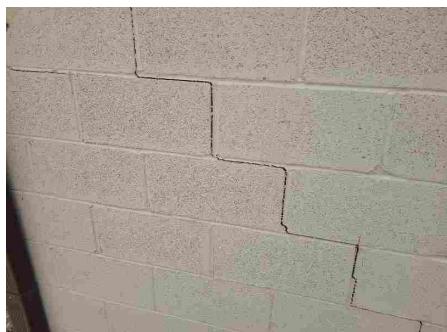
West large step crack

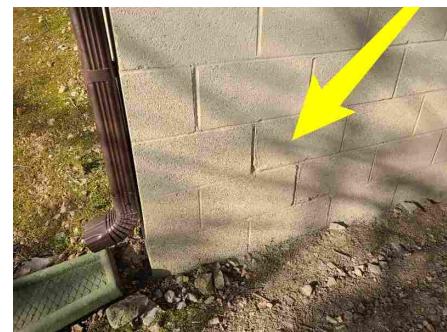
North, step crack

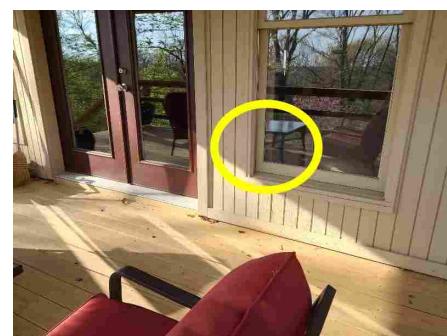
Broken glass

POOR Window(s) broken / glass, living room.

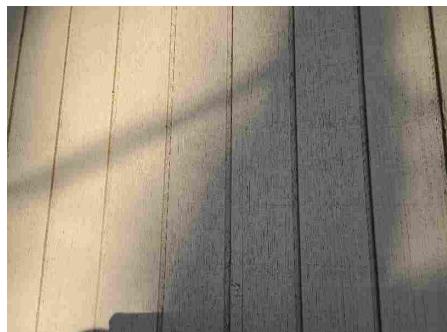
Damage

Siding had some damage, recommend repairing/replacing damaged sections.

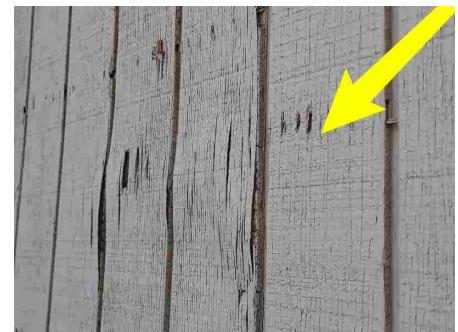
Damage / rot

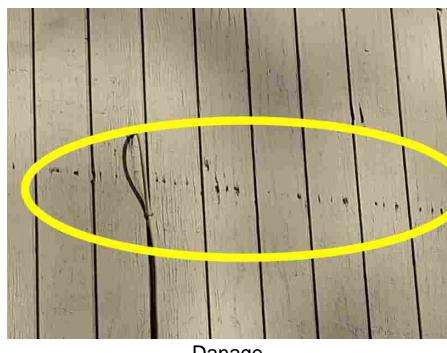
Damage

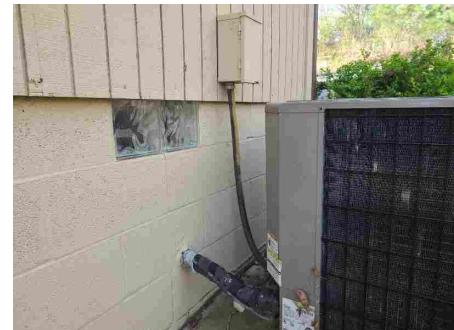
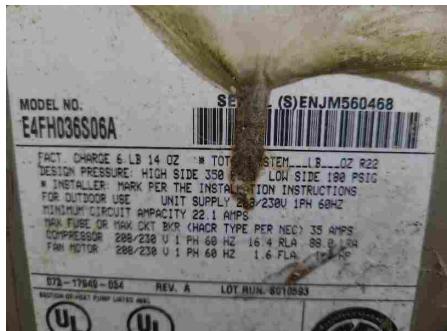
Not fully level

Damaged fins

The condenser fins have some damage, and the unit will not perform as efficiently as it should

MON The ac / compressor appears to be past its life expectancy, recommend budgeting for replacement sooner than later.

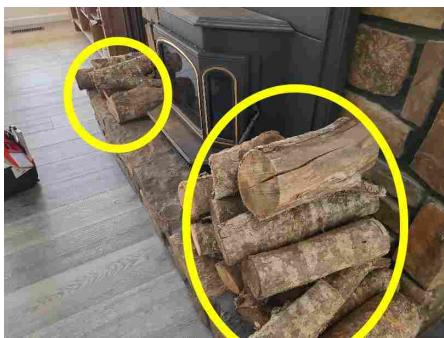
Do not store wood here, fire hazard

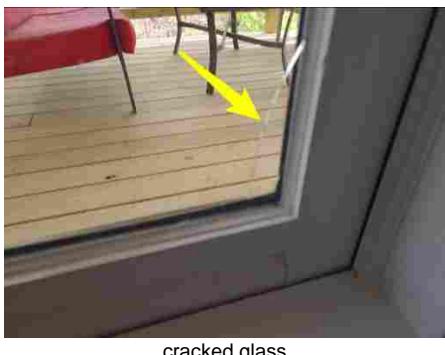
Left window cracked

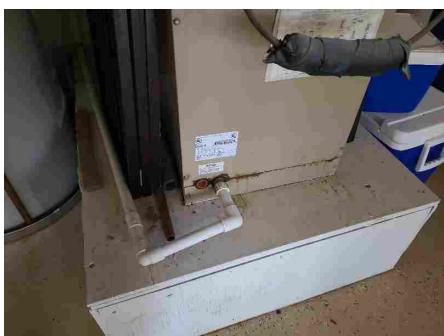
Some rusting / showing its age

Ac / evaporator: there was no secondary drain line, overflow pan or float switch, recommend adding one so there is a backup to the main line.

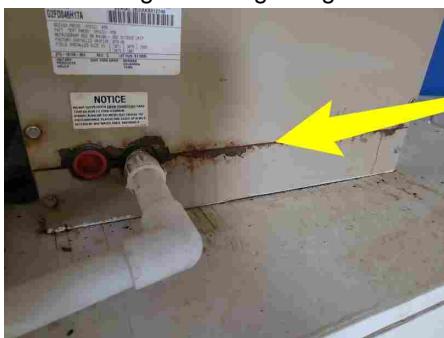
Rusting

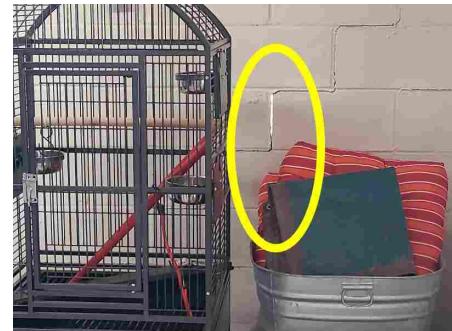
Light coming thru , west wall, large crack

Cracks over 3/8" wide are an indication of a potentially serious problem, recommend further evaluation by a foundation specialist.

Active cracks with sharp edges are noted as a major defect because they indicate a failure in progress and a situation that could grow worse, recommend further evaluation by a foundation specialist.

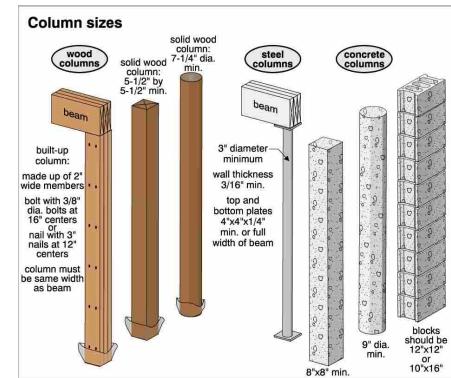
Poor

POOR Columns leaning / cracked, recommend further evaluation and repair.

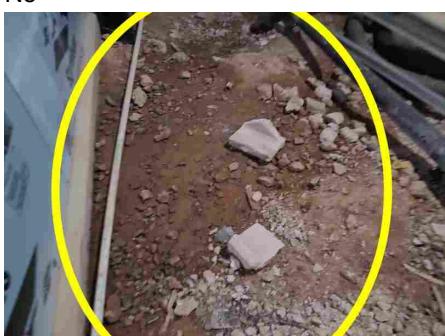
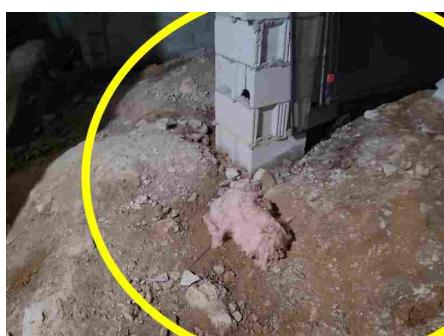
Poor

It's recommended to have poly sheeting on the ground floor in a crawl to help reduce ground moisture related issues like, mildew mold potentials.
