Home Inspection Report

13 Sample, NWA, AR 72631

Friday August 23, 2019

Illuminating-Home-Inspections
14982 Elkhorn Springs Rd
Fayetteville, AR 72704
(479) 466 9417
eric@illuminating-home-inspections.com

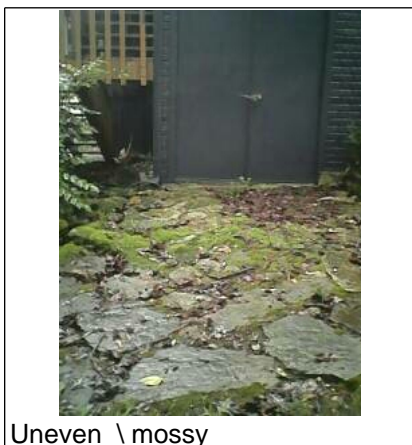
Uneven slabs \ stones in walks, could be a tripping hazard.

Uneven \ mossy

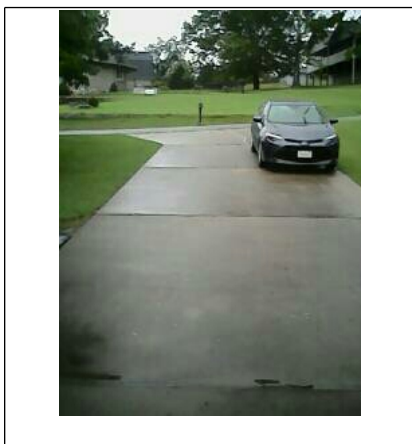
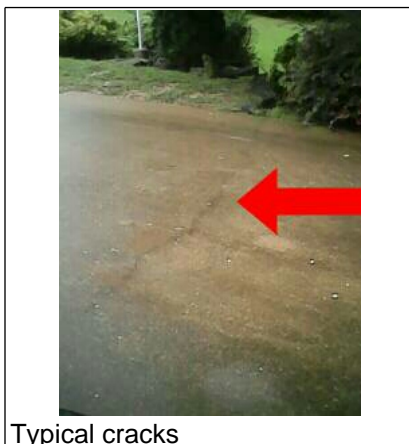
Typical cracks

Recommend sealing gaps and cracks in driveway to help keep water from seeping underneath the driveway which over time can cause the driveway to lift and/or sink.

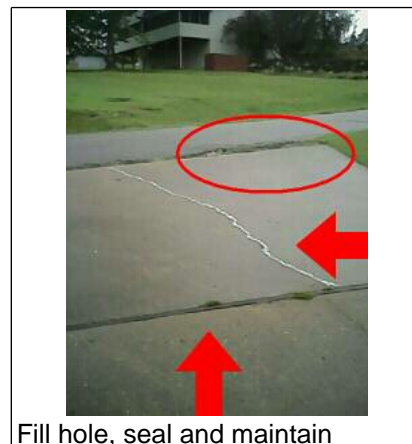
Fill hole, seal and maintain

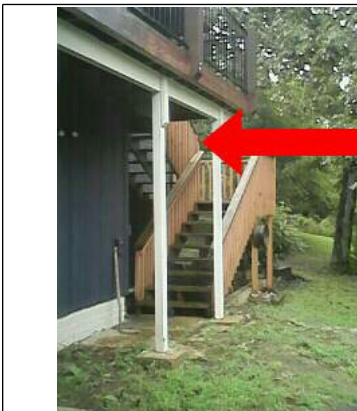
North steps : hand rail loose

Loose, recommend bracing

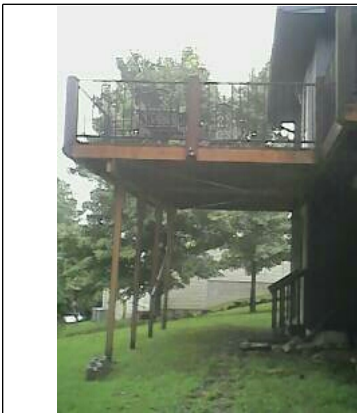
Recommmend bracing \ loose

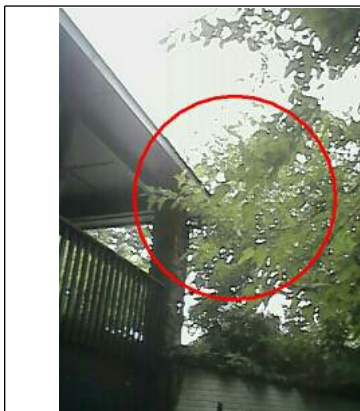
SE

Comments There are low areas of grading next to the foundation, recommend adding additional soil and slope away from foundation. This will help keep excessive water from compromising the foundations integrity. Recommend additional backfill to create a proper pitch away from the house. Recommend trimming trees/vegetation so it does not come into contact with the home. Wind can cause them to rub on the exterior causing premature failure of shingles, siding and trim.

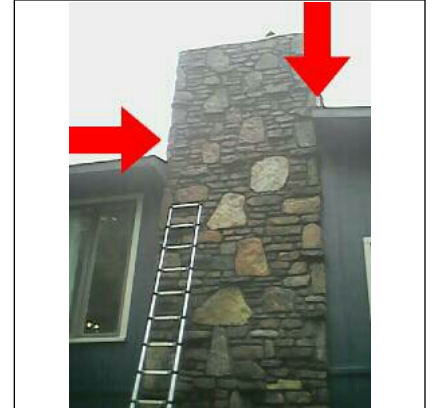
Recommend flashing to divert away from chimney

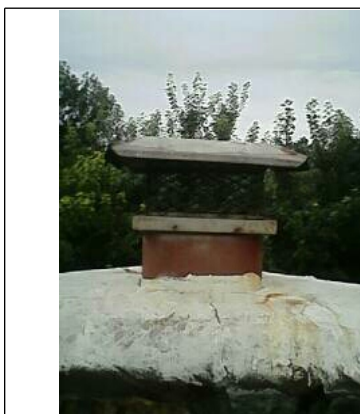
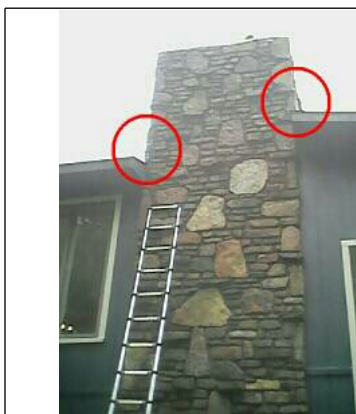
Recommend kick out flashing to keep water diverted from fascia, gutters also recommended

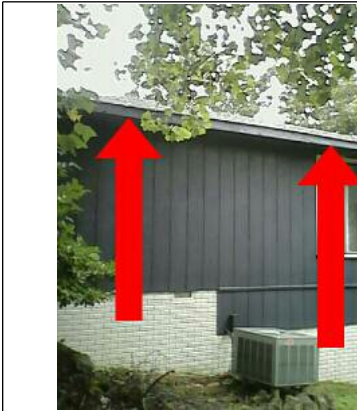
North, no gutters

Comments Gutters on only a portion of the house, recommend additional gutters where needed.
 We highly recommend gutters, down spouts and splash guards on homes. Most water damage caused by rain starts around the roof structure, fascia, soffit and foundation. The rain gutter system is designed to remove water away from those areas to protect your home from water intrusion and foundation problems. Some of gutters are full of debris, recommend cleaning. Clogged gutters can overflow, break and put stain on the roof itself causing damage.
 Recommend maintaining downspout discharge a minimum of 5-6' away from the house.
 Area of damage, recommend repair or replacement.

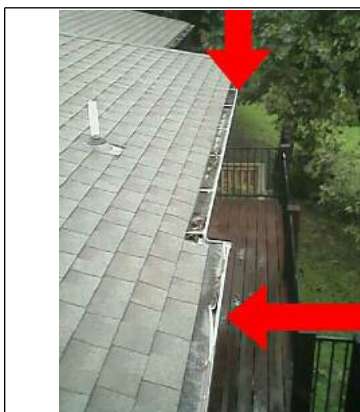
Damaged\ full

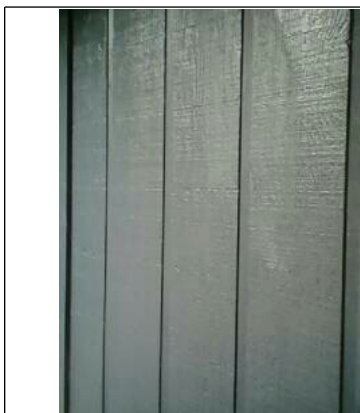
Damaged

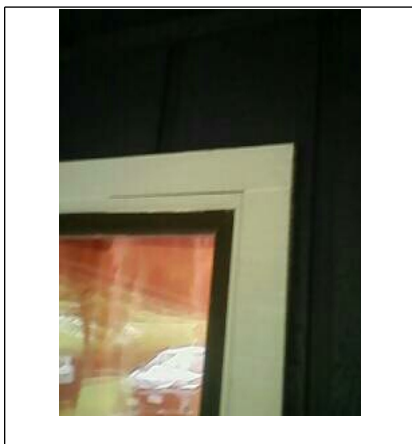
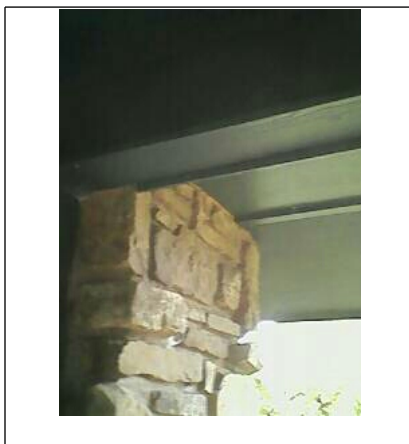
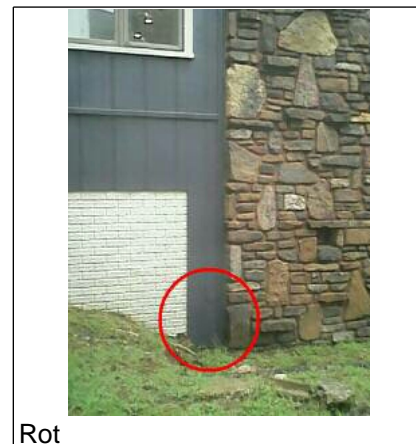
Comments Some rotted trim boards recommend repair/replacing damaged sections

Rot

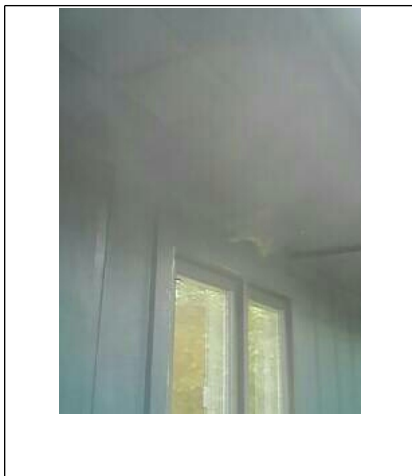
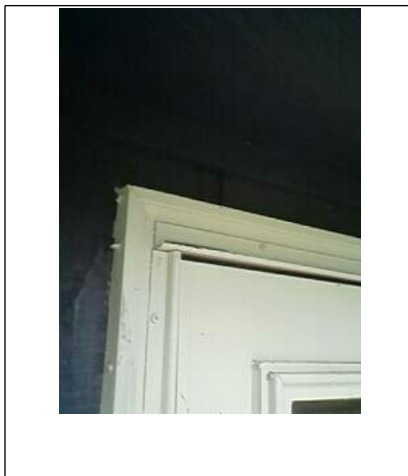
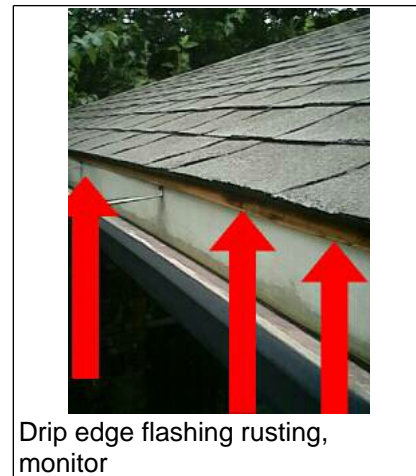
Flashing at drip edge shows signs of some rusting, monitor.

Drip edge flashing rusting, monitor

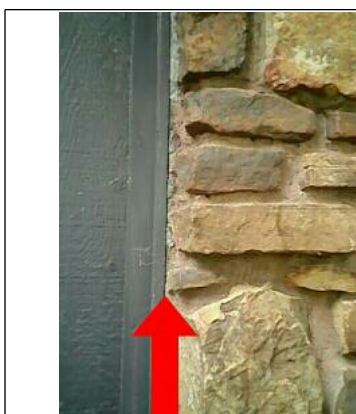
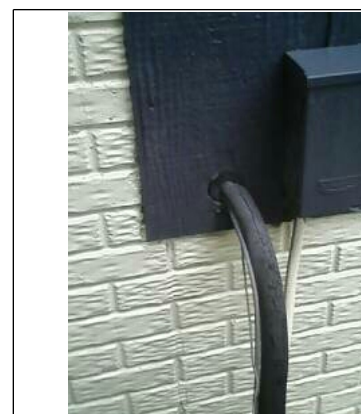
Caulk and maintain

Recommend caulking and maintaining caulk around windows, doors, corners, utility penetrations, gaps etc..

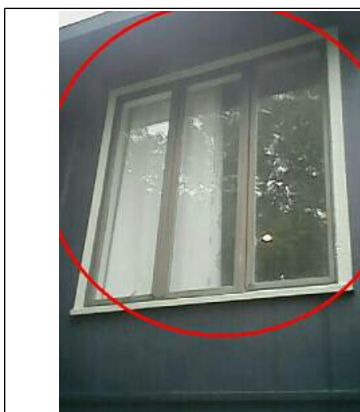
No screens

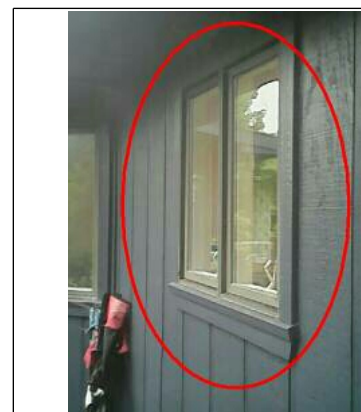
No screens

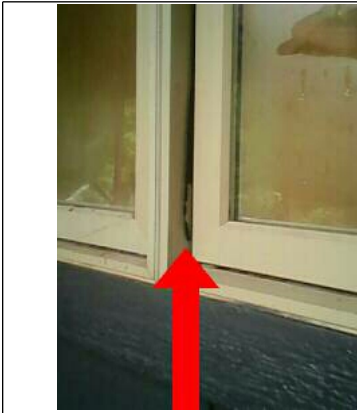
Loose weather stripping on several windows

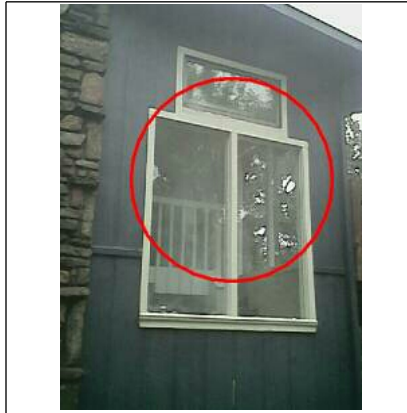
Fogged windows

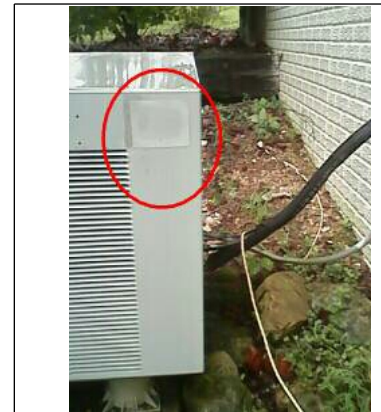
Faded \ missing label

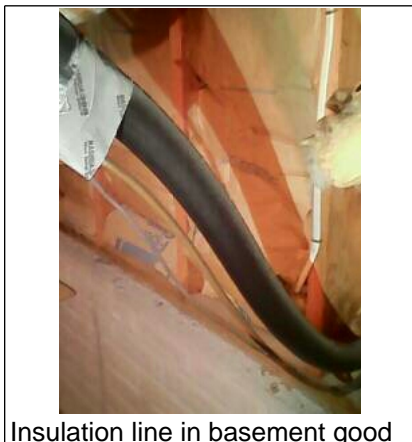
Insulation line in basement good

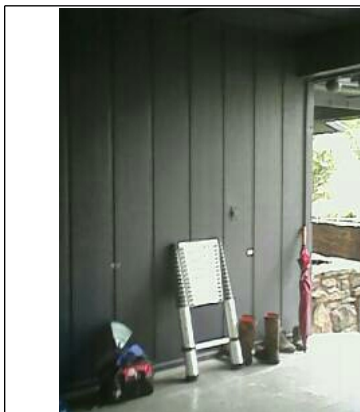
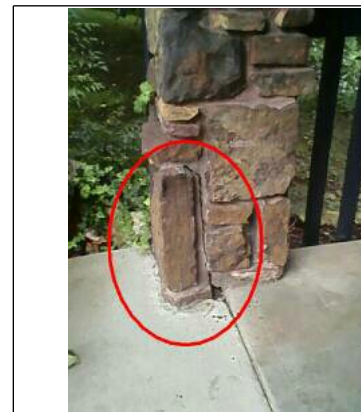
Loose stone, recommend repair

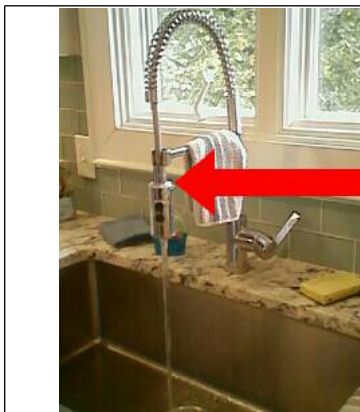
Comments Water flow was normal with several fixtures operated at the same time.
There were no visible active piping leaks at the time of the inspection.
Drain lines had no visible leaks or signs of backup at the time of inspection.
Sink faucet leaks at handle, recommend repair/replace.
Water temp was 125

Handle leaks

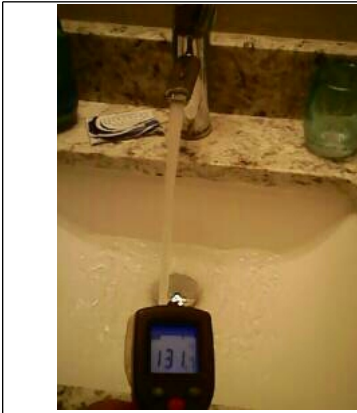
Temp 131

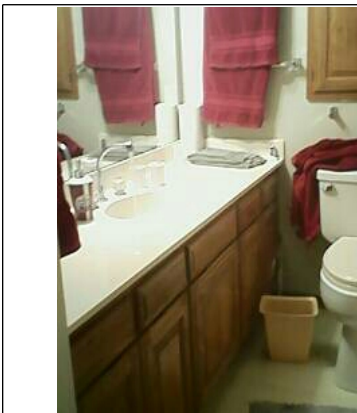
Comments Sink drain shows sign of back-up, recommend repair.
 Moisture stains present under sink with high moisture content. Recommend repair \ replace or at least monitor.
 Outlets were randomly tested and had correct polarity.
 Water temperature was 118.

Slow to drain

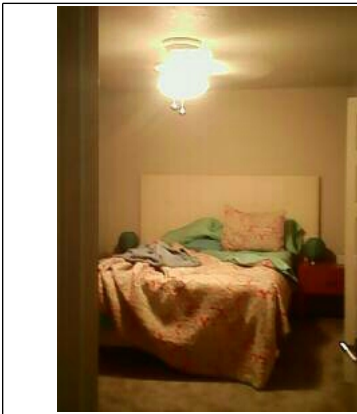
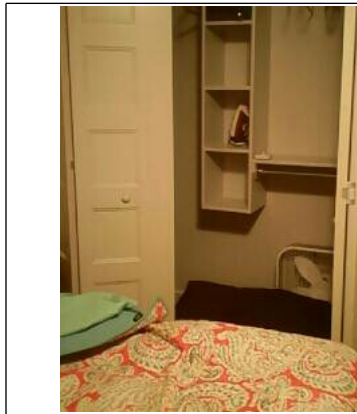
Comments Ceiling fan is wobbling, recommend repair.
No window screen(s)

Fan wobbles

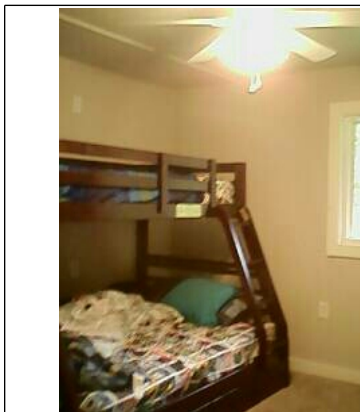
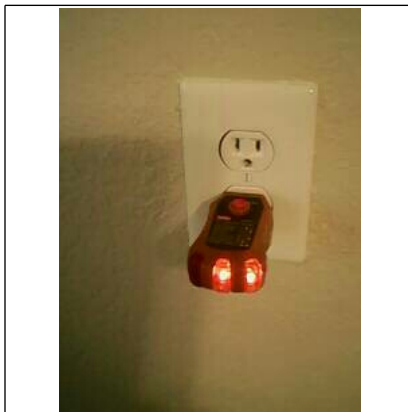
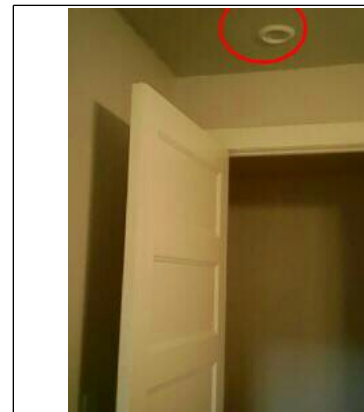
Comments No window screen(s)
Smoke alarms should be installed in all bedrooms.

Missing smoke detector

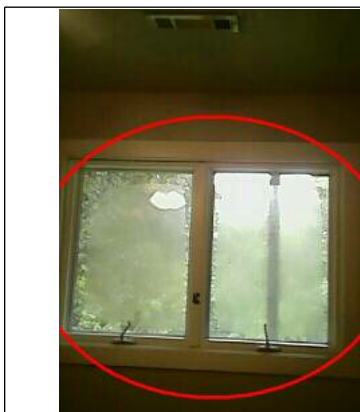
No screens

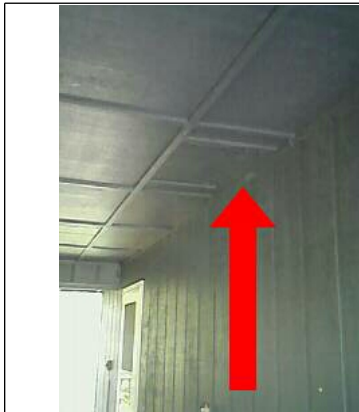
Access panel

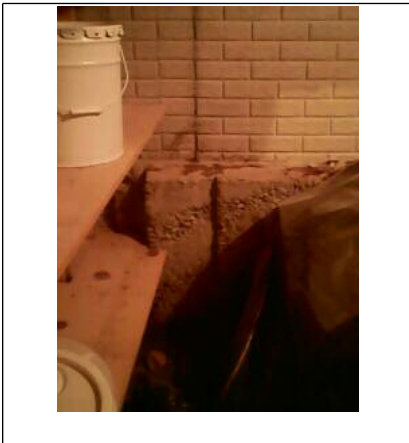
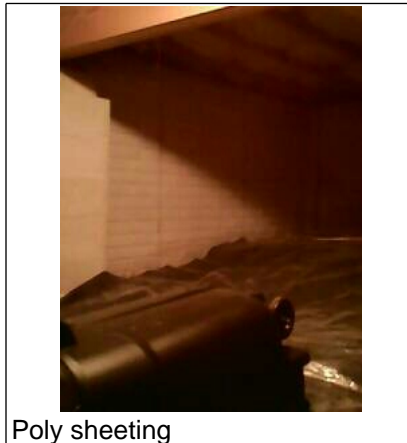
Poly sheeting

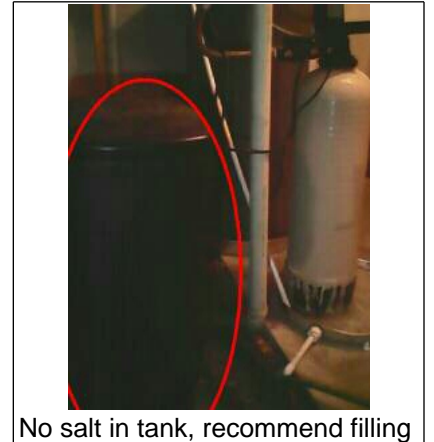
No salt in tank, recommend filling

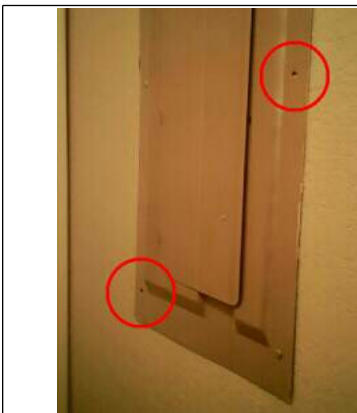
Comments Panel size appeared to be compatible to service size.
Panel cover was missing some screws recommend adding proper screws to secure panel cover
Outlets were randomly tested and had correct polarity, except as noted.
There is a loose wire in the main panel. There should be no lose wires in the panel, recommend repair.

Missing screws

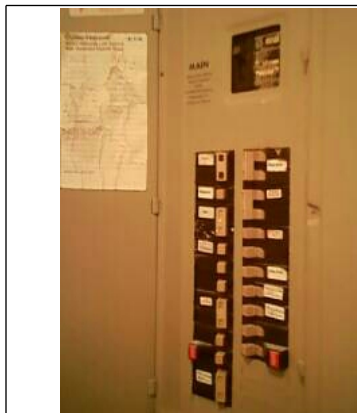
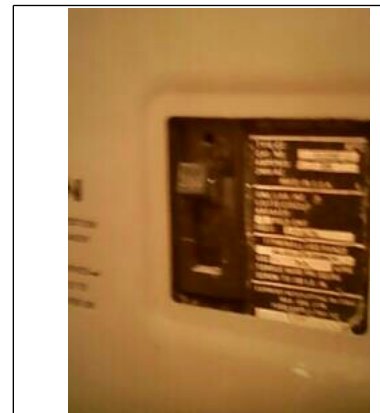
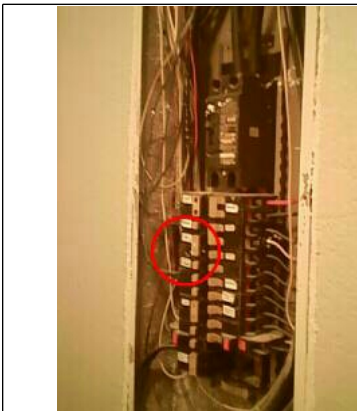
Loose wire

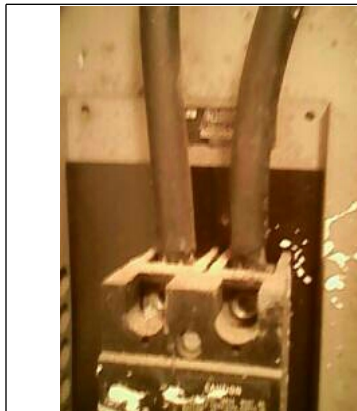
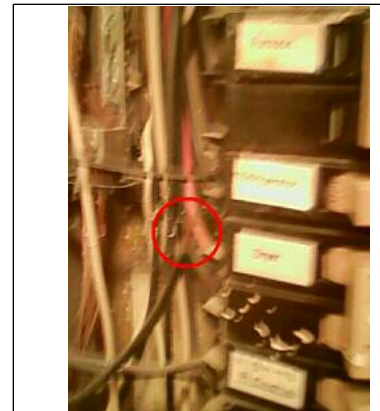
Loose wire

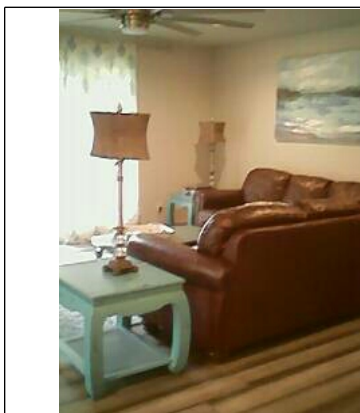
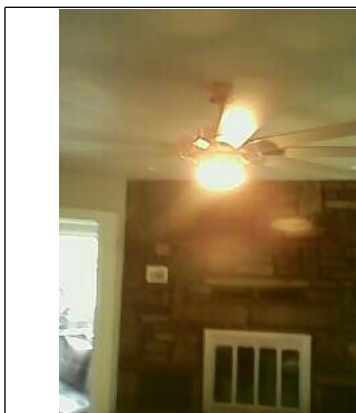
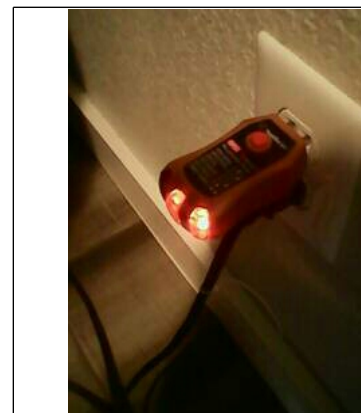
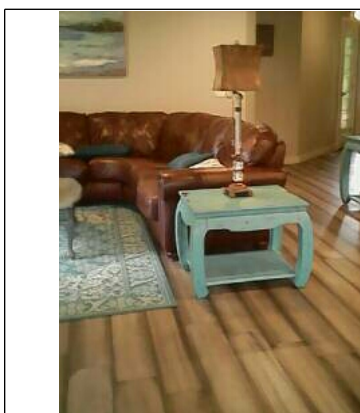
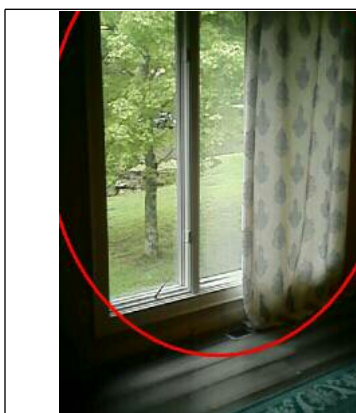
Comments No window screen(s)
Windows had some weatherstripping damage.

No screens

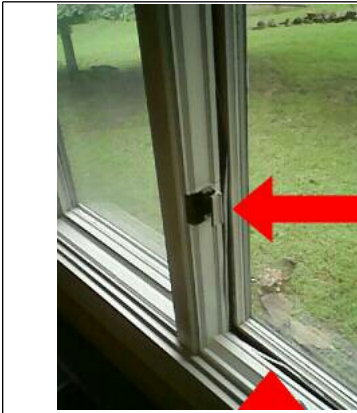
Weather stripping damaged
