ILLUMINATING
HOME INSPECTIONS

Home Inspection Report

LOCATED AT:
1234 Sample Rd
Mountianburg, AR

INSPECTED ON:
Sunday, April 9, 2023

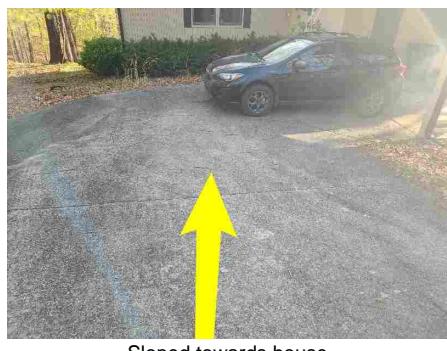
Sloped towards house

Satisfactory
Typical cracks
Pitched towards home

MON Recommend sealing gaps and cracks at driveway to keep water from getting underneath which can cause lift or sink.

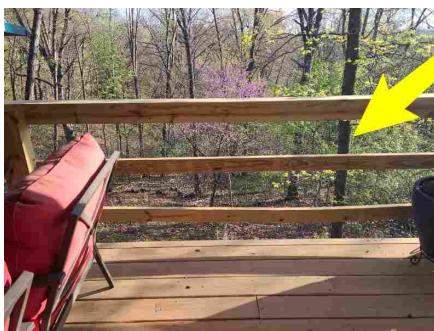
Climable

SAFT The railing is climbable and should have spindles instead so that a small child can't climb over and fall, recommend repair.

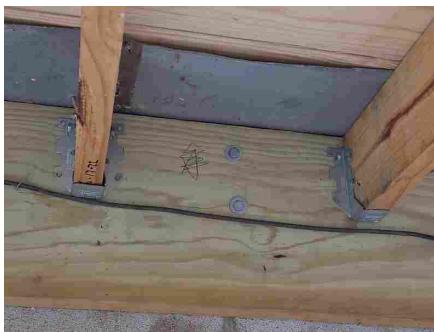
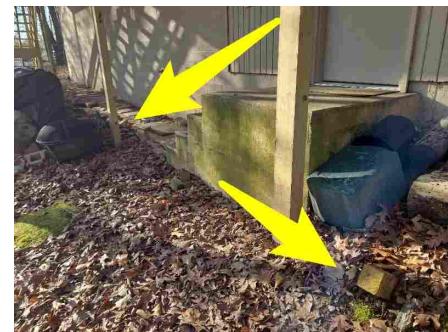
Wood to soil

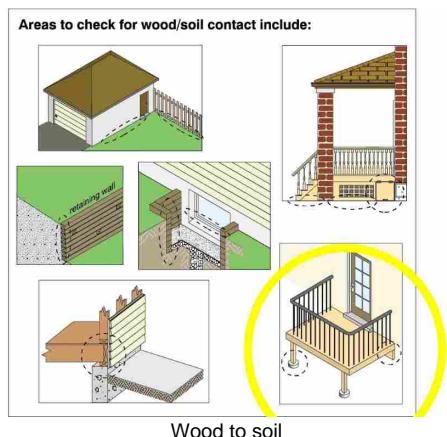
Wood to soil

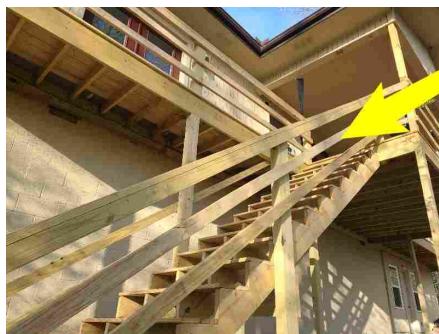
Climable railing. Safety hazard

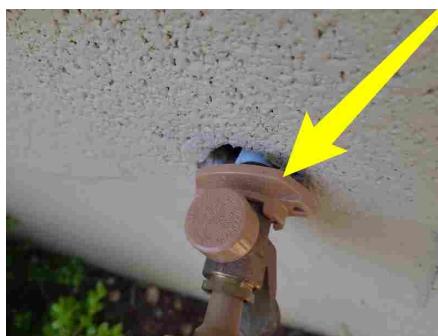
Loose / leaks in crawl , north

North hose / pipe split/dripping, recommend licensed plumber repair

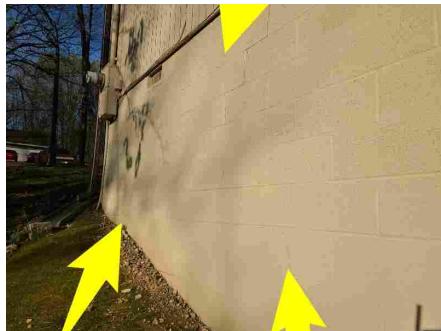
Several steps cracks and block cracks

Active cracks with sharp edges are noted as a potential major defect because they indicate a failure in progress and a situation that could grow worse, recommend further evaluation by a structural engineer and/or foundation specialist.
Foundation not fully visible.

Recommend further evaluation by a foundation specialist.

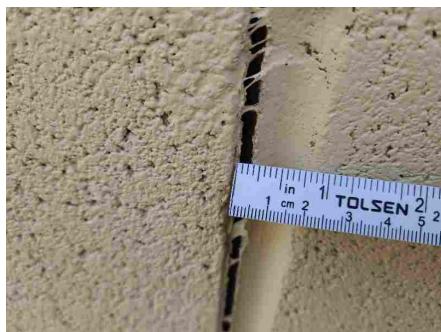
North, step crack

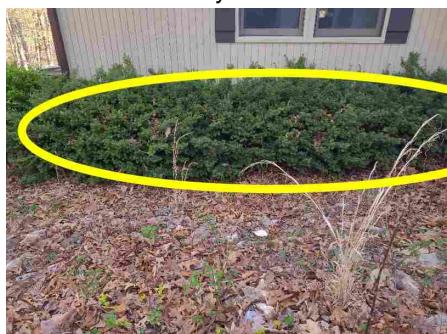
Not visible

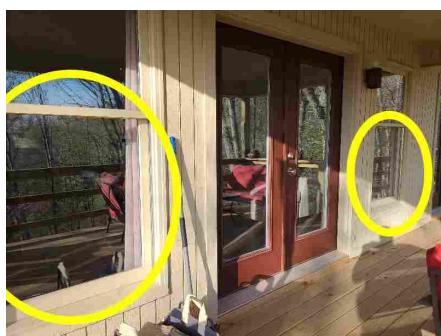
No screens

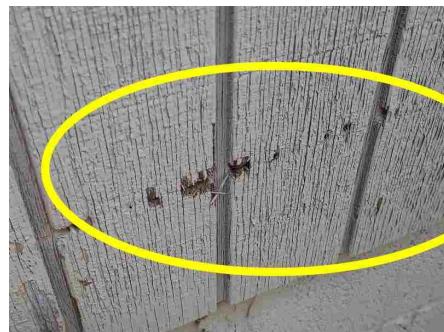
Damage

Siding had some damage, recommend repairing/replacing damaged sections.

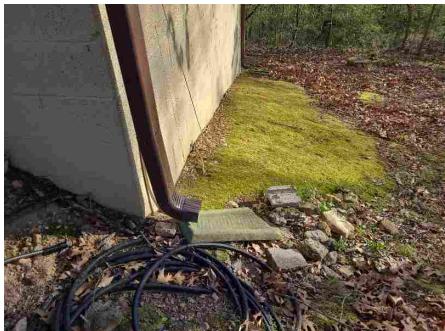
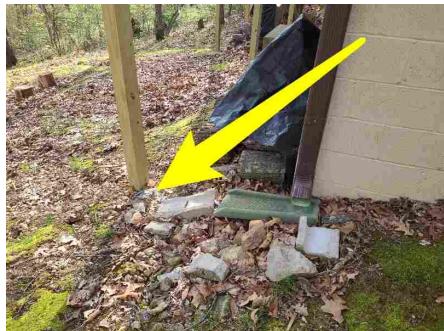
Loose

Divert flow around support post

EXTENSION RECOMMENDED

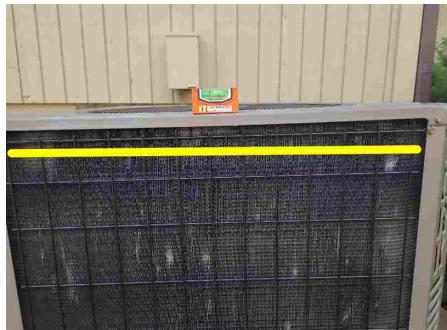
Not fully level

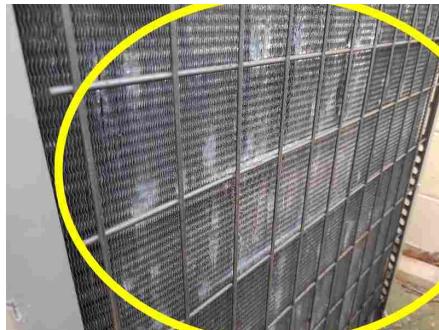
Damaged fins

The condenser fins have some damage, and the unit will not perform as efficiently as it should

MON The ac / compressor appears to be past its life expectancy, recommend budgeting for replacement sooner than later.

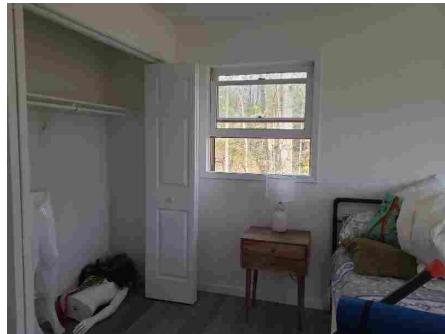
Bedroom 2

No chain pull for fan, not tested

Recommend repair chain pull

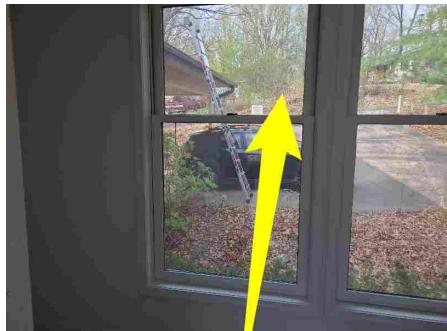
WINDOWS

Window does not stay up

Windows don't stay up, recommend repair / replacement.

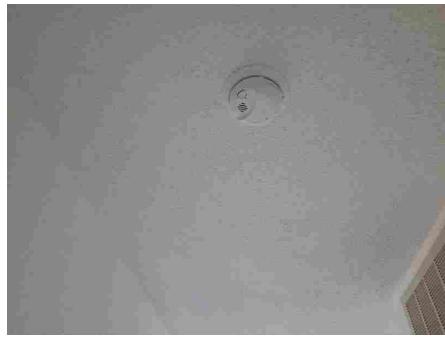
SMOKE DETECTOR

MON Smoke detector was not tested at the time of inspection.

Recommend changing smoke detectors /CO batteries when you first move in and then every 6 -12 months.

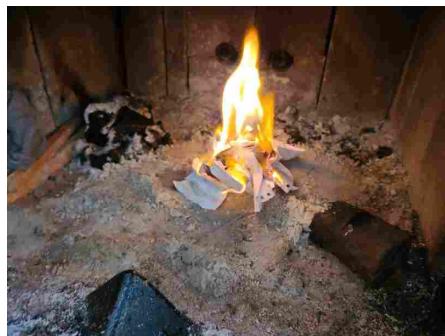
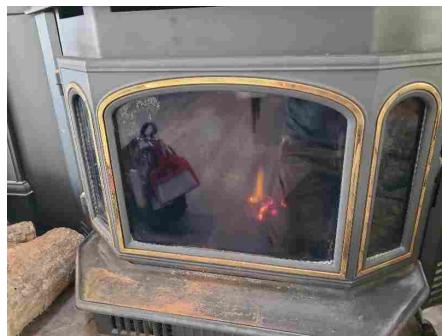
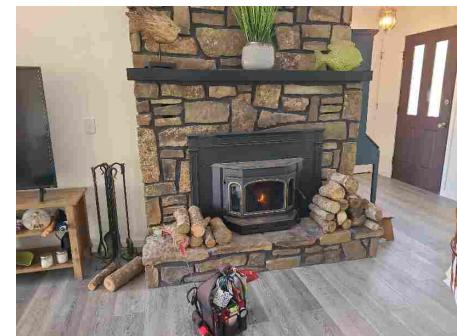
Do not store wood here, fire hazard

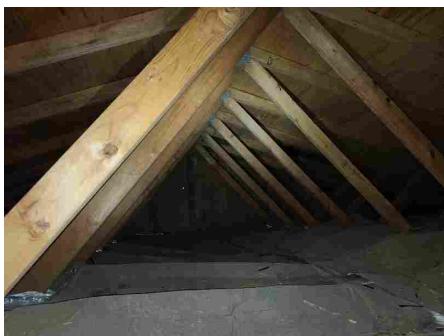
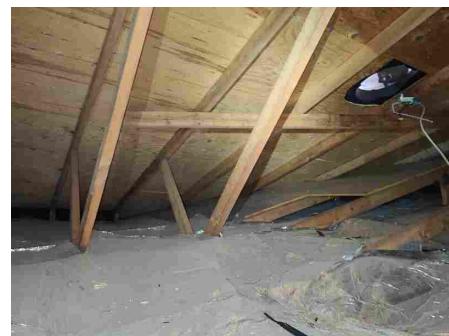
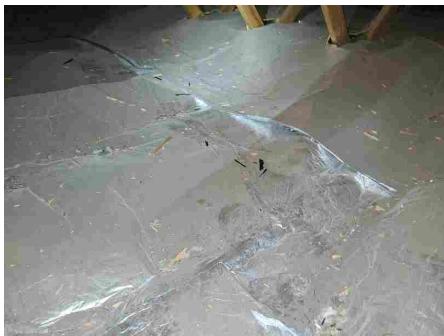
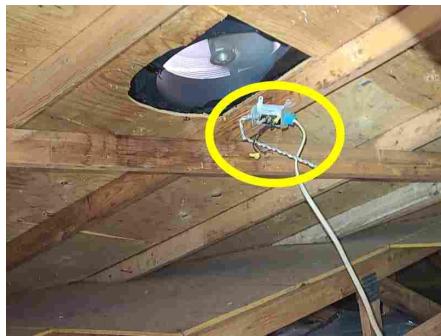
Open junction box

Capped wires with no junction box, recommend repair.

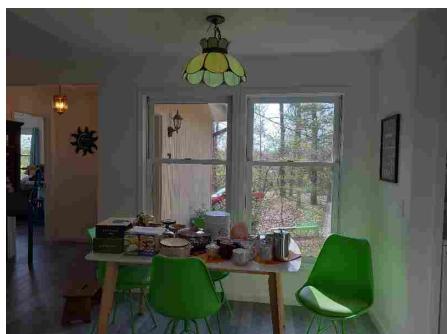
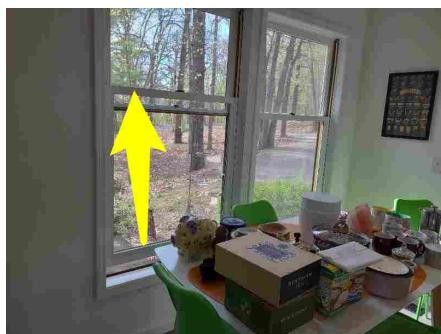
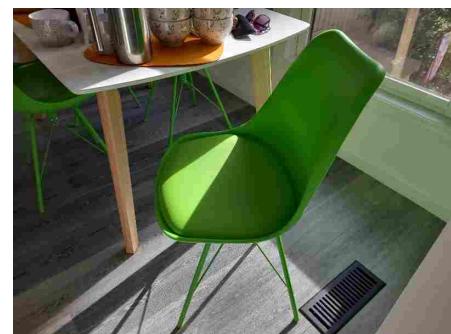
Front

Window does not stay up

The window springs are not operating, window does not stay up, recommend repair/ replace.

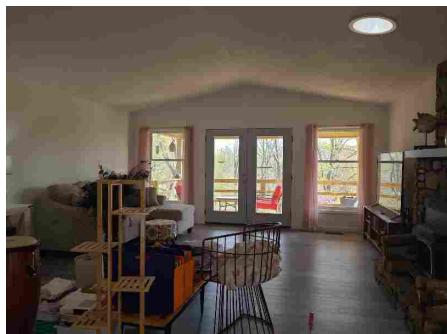
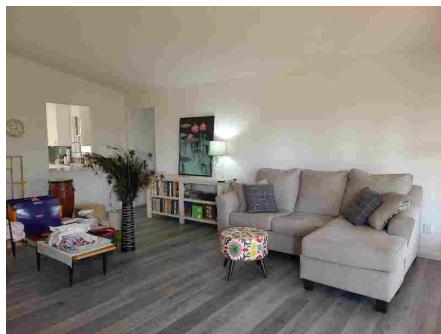
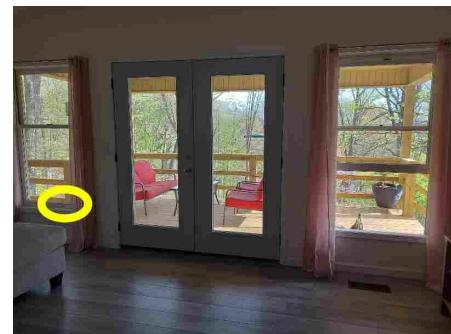
Back

Left window cracked

Cracked glass

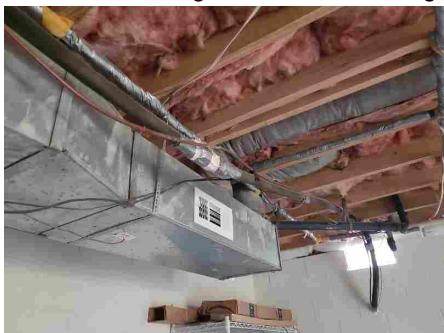
REFRIGERANT LINES

Insulation missing, recommend adding

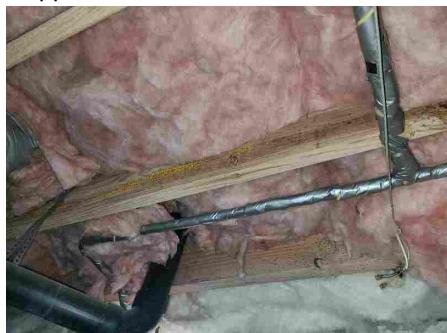
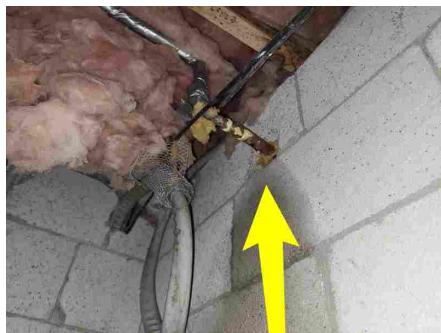
Split / hole in pipe crawl , south front hose bib

Leaking

POOR Spit copper pipe in crawl, leaking, recommend further evaluation and repair.

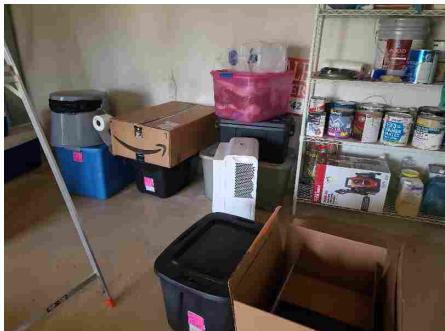
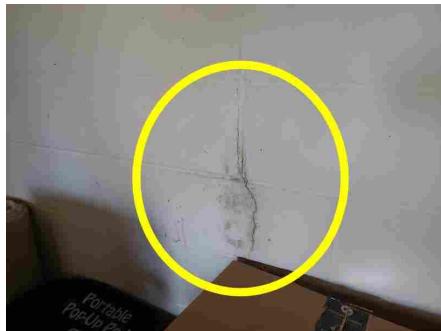
North wall / mildew / mold like potential,
recommend further evaluation

Foundation wall in basement area appears to have what looks like mildew / mold, recommend further evaluation.

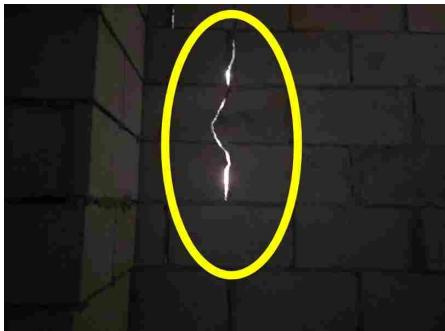
East wall, large crack, light coming thru

Cracks over 3/8" wide are an indication of a potentially serious problem, recommend further evaluation by a foundation specialist.

Active cracks with sharp edges are noted as a major defect because they indicate a failure in progress and a situation that could grow worse, recommend further evaluation by a foundation specialist.

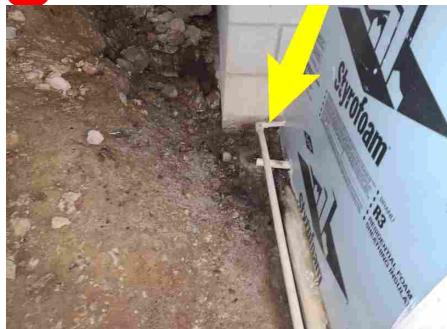
POOR Yes

Water from water heater

Drain pipe from pan should not drain into the crawl, it should drain to the exterior. Crawls should remain as dry as possible to help avoid moisture damage and the like.

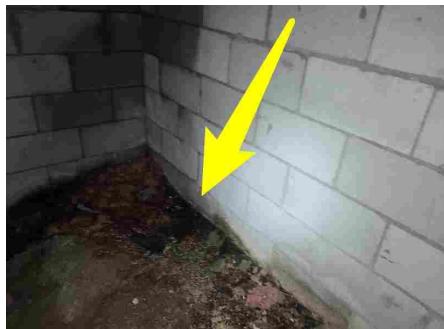
Water from cracked copper pipe

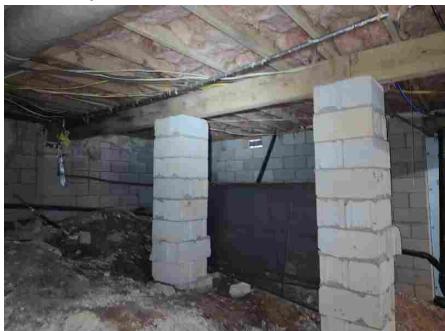
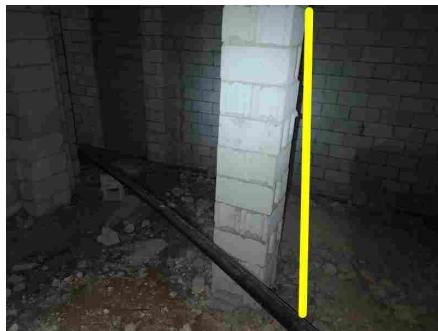
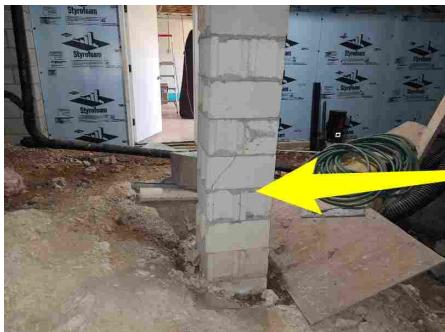
POOR Columns leaning / cracked, recommend further evaluation and repair.
