Home Inspection Report

13 Sample, NWA, AR 72631

Friday August 23, 2019

Illuminating-Home-Inspections
14982 Elkhorn Springs Rd
Fayetteville, AR 72704
(479) 466 9417
eric@illuminating-home-inspections.com

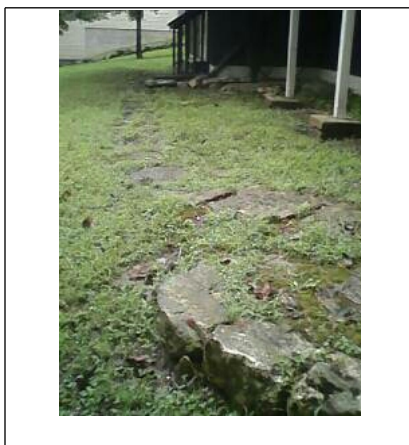
Uneven \ mossy

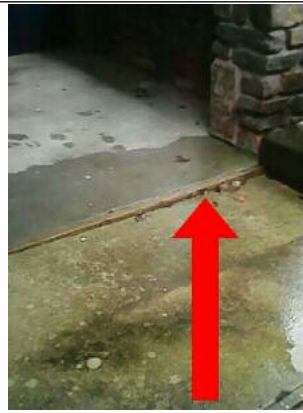
Seal and maintain

Recommend sealing gaps and cracks in driveway to help keep water from seeping underneath the driveway which over time can cause the driveway to lift and/or sink.

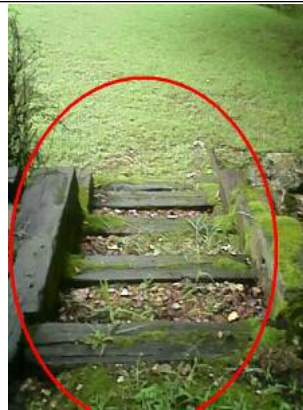
Side steps: Mossy \ slippery

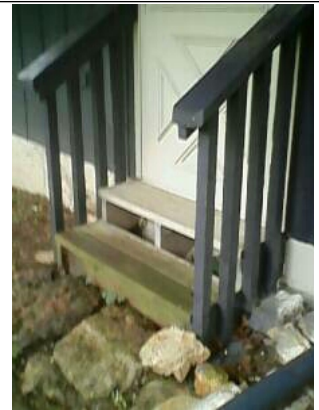
North steps : hand rail loose

Loose hand rail recommend repair/ replace.

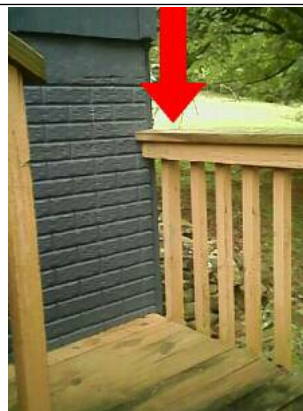
Loose, recommend bracing

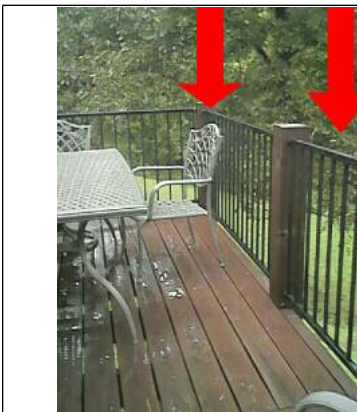
Recommmend bracing \ loose

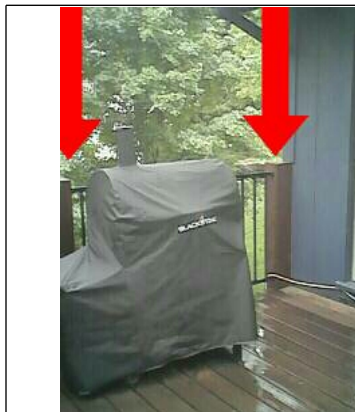
Loose

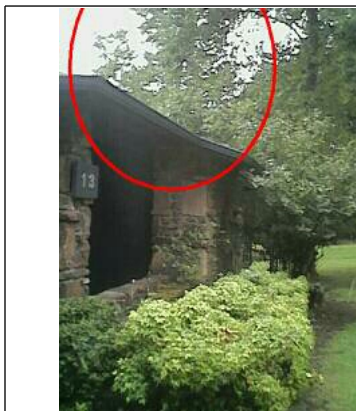
East

Comments There are low areas of grading next to the foundation, recommend adding additional soil and slope away from foundation. This will help keep excessive water from compromising the foundations integrity. Recommend additional backfill to create a proper pitch away from the house. Recommend trimming trees/vegetation so it does not come into contact with the home. Wind can cause them to rub on the exterior causing premature failure of shingles, siding and trim.

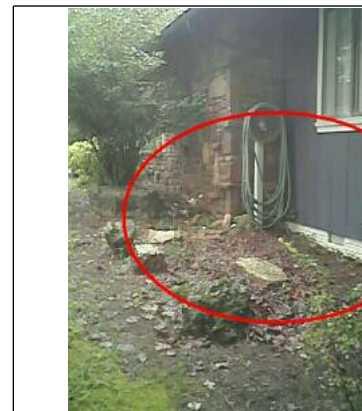
East back fill

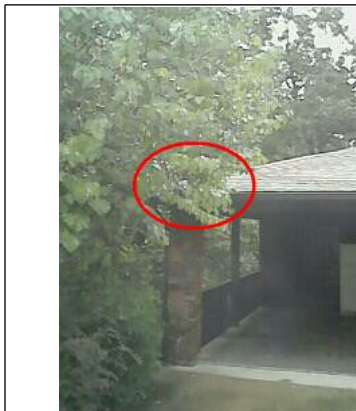
Trees touching rtoof

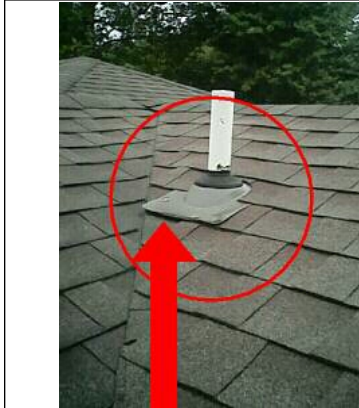
Comments Pulled away from roof - recommend sealing.
Kickout flashings are missing. Kickout flashings divert water away from wall surfaces that abut roof. When

Lifted

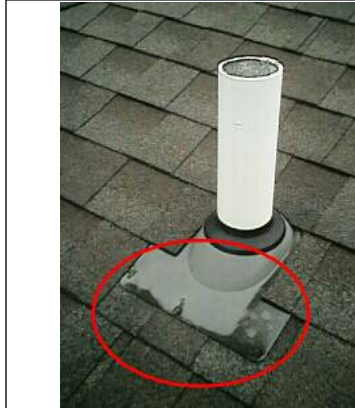
Nail heads need caulk and maintain

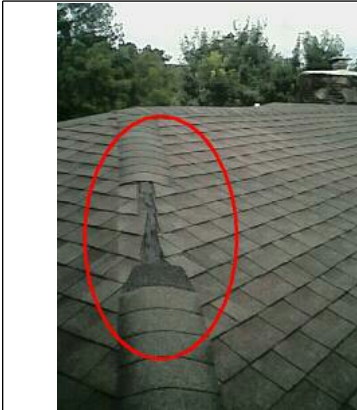
Carport Missing shingles on ridge

Comments Roof was showing normal wear, but appears to be in overall adequate condition, except where noted.
 Recommend cleaning moss off of the roof.
 Missing tabs or shingles recommend repair or replacement.
 Due to varying insurance standards, it is recommended that your insurance company be contacted about the insurability of the roof.

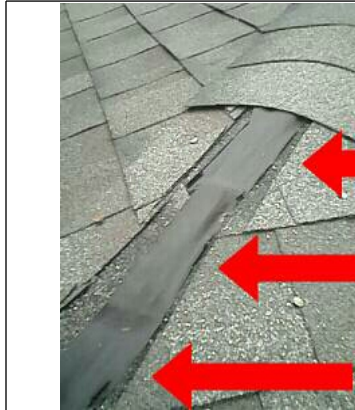
Missing shingles exposed felt

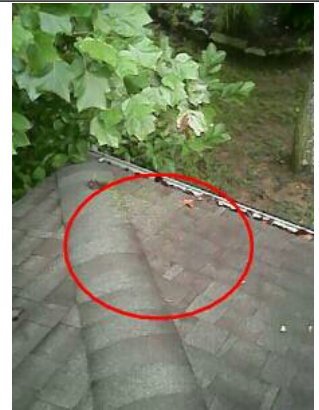
Moss

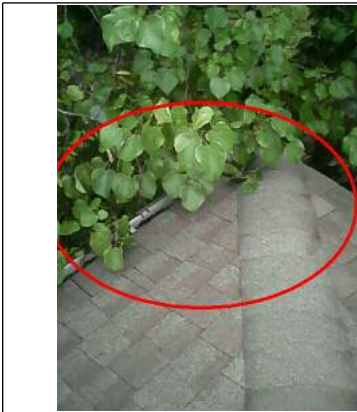
Trees touching roof

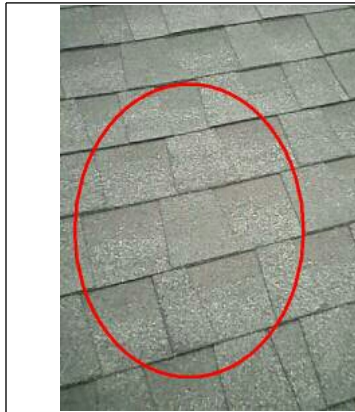
Missing granular

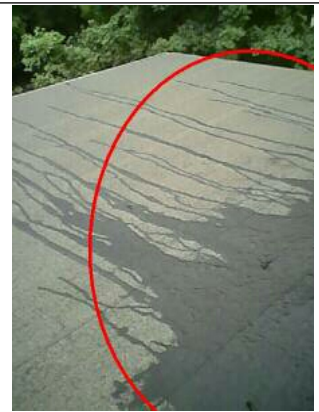
Tared over at chimney and rolled area west

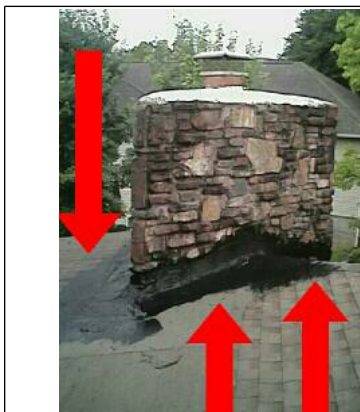
Comments Flashing around chimney is completely covered with tar and could not be inspected.
 Chimney flue was not accessible so not evaluated
 Have your chimney inspected and cleaned regularly to get rid of creosote build up which can catch fire and spread to the attic and other areas of the home.

Tar

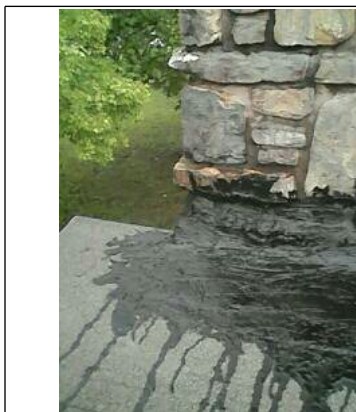
Tar

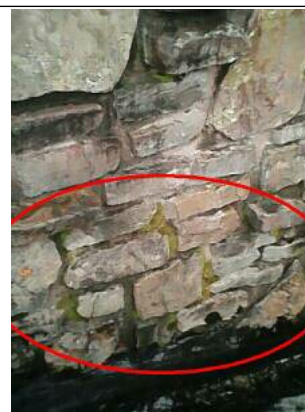
Moss

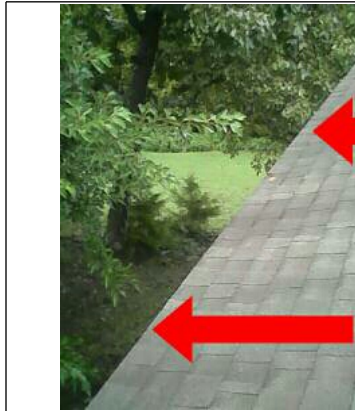
South, no gutters

Gutters are recommended where missing. Gutters help guide water away from the exterior walls and foundation. Without gutters you risk window damage, siding damage and potential foundation issues caused by excessive water. Down spouts and or splash guards are recommend to help divert water away from the foundation.

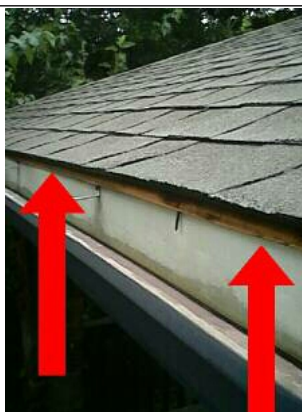
Flashing rusting

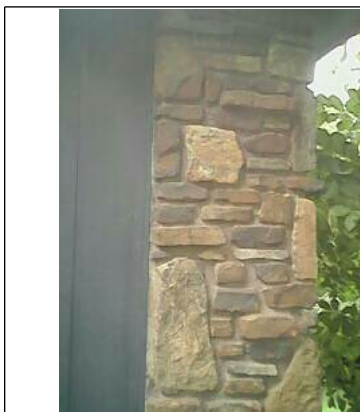
Damaged

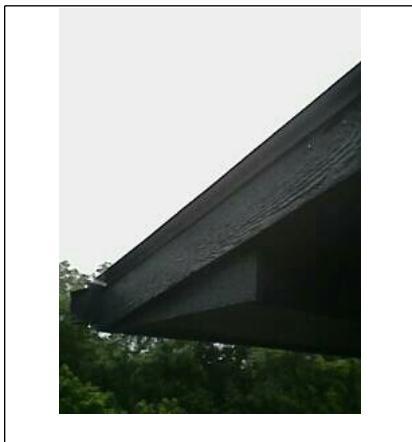
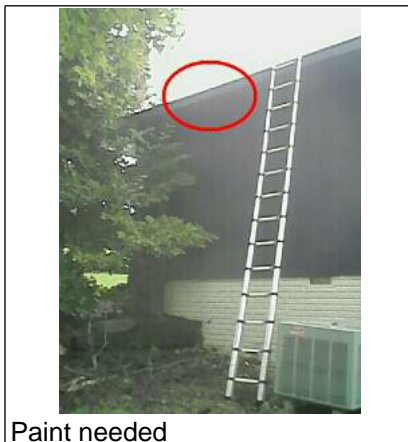
Paint needed

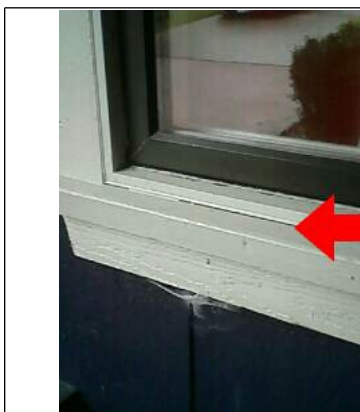
Caulk and maintain

Recommend caulking and maintaining caulk around windows, doors, corners, utility penetrations, gaps etc..

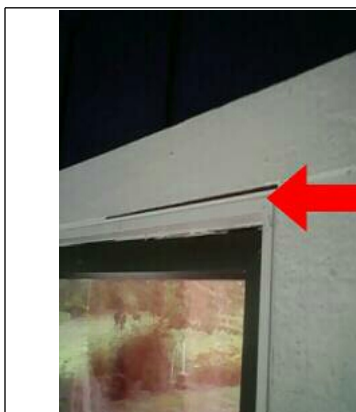
Caulk and maintain

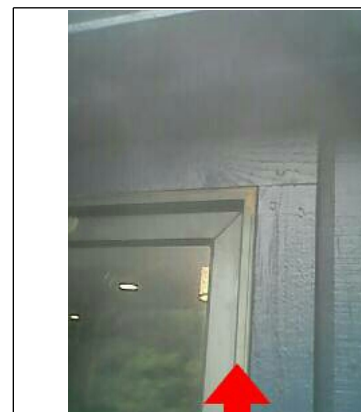
Caulk and maintain

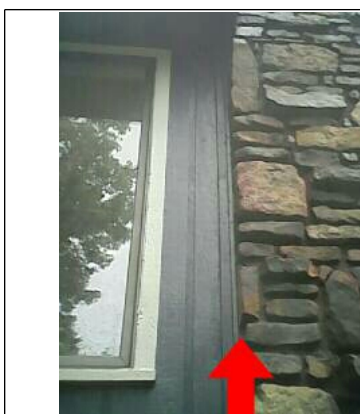
Caulk and maintain

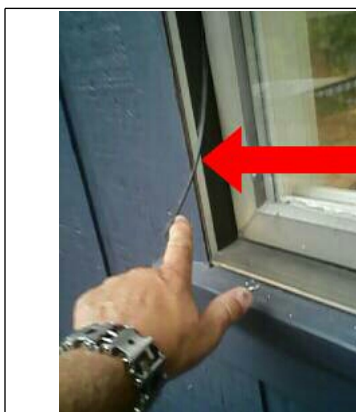
Comments Some screens not installed.
 Several windows have damaged \ worn weather stripping.

Kitchen window strip damage \ no screens

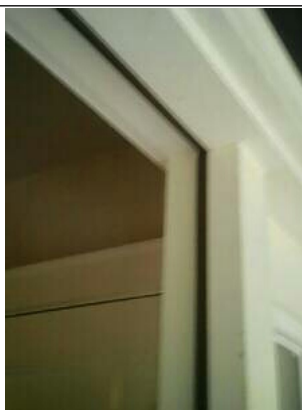
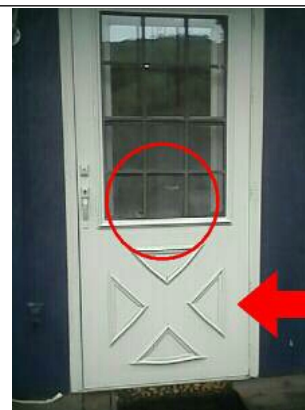
Deck, ripped screen \ damaged trim

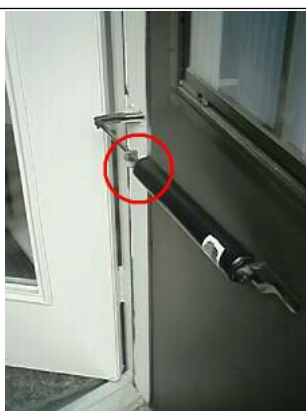
Tab does not hold screen door open

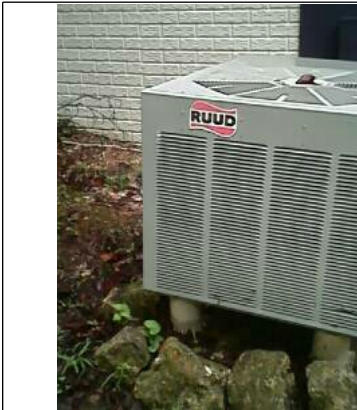
Not level

Level ☐ Yes ☒ No ☒ Recommend re-level unit

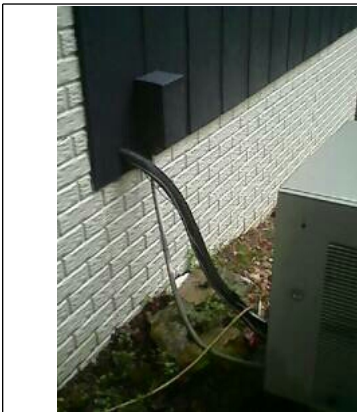
Comments Condensing unit not level, recommend re-leveling unit
Heat pump was in normal working order.
Damaged / missing insulation on the AC refrigerant line, recommend adding insulation. This will help keep the refrigerant line from capturing additional heat and helps prevent the line from sweating.
The label on the unit was / faded missing. Therefore, we did not see the model, serial number or the maximum breaker rating for the unit.
Consumer Reports states the average life expectancy for an AC \ Heat pump is 15 years.

Torn insulation

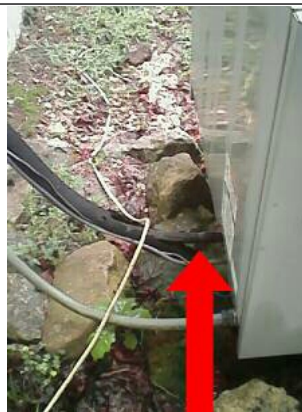
Serial #: Unknown faded \ missing label

Faded \ missing label

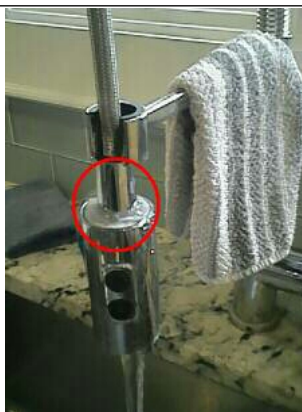
Comments Water flow was normal with several fixtures operated at the same time.
There were no visible active piping leaks at the time of the inspection.
Drain lines had no visible leaks or signs of backup at the time of inspection.
Sink faucet leaks at handle, recommend repair/replace.
Water temp was 125

Handle leaks

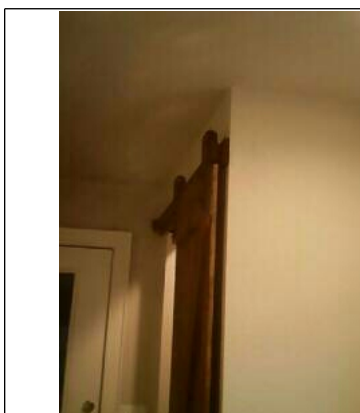
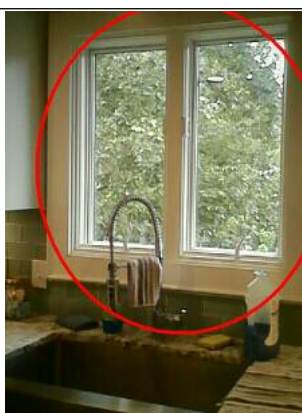
Comments Windows have no screens.

No screens

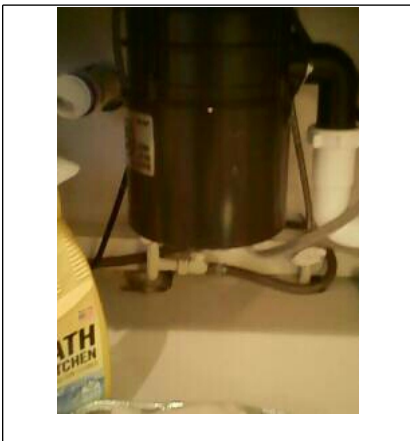
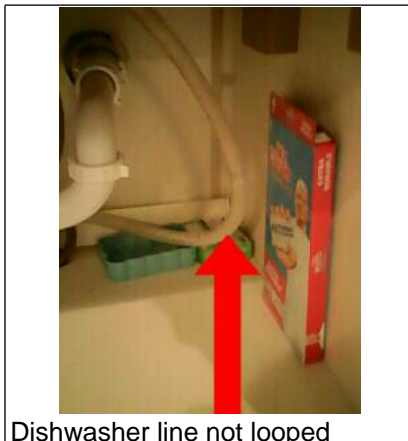
Comments Appliances only tested for operation, working or not. Quality or extent of operation not part of testing or inspection
 Most dishwashers are produced with and are internal loop line and air gap, but there is no way to tell for sure.

Dishwasher line not looped

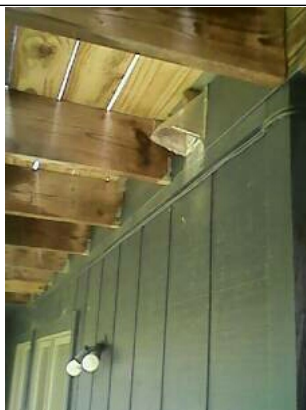
Exterior vent

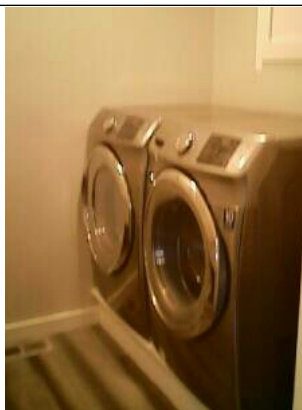
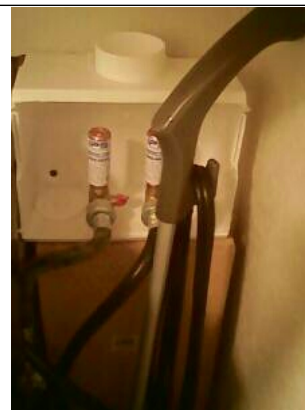
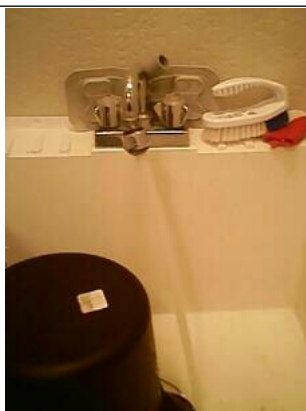
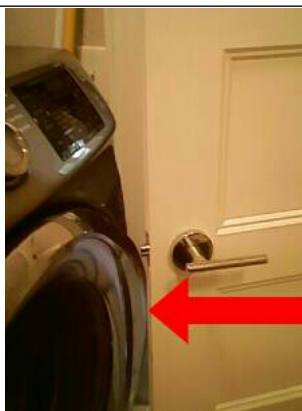
Comments Laundry room door does not close.
 Washer and dryers are not tested.

Door does not shut due to machine blocking

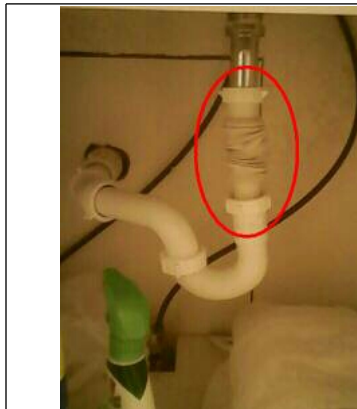
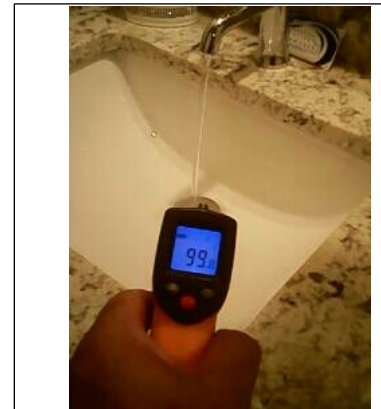
Comments Drains show no signs of back-up during time of inspection.
 Outlets were randomly tested and had correct polarity.
 Water temperature was 99.
 Handyman work at drain line, non professional, but is working fine.

Water temp 99

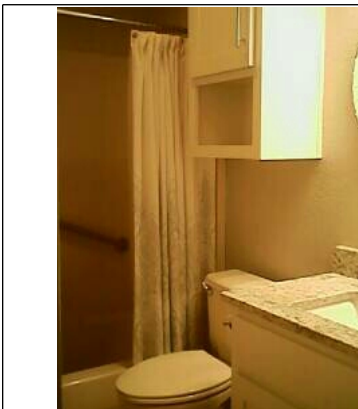
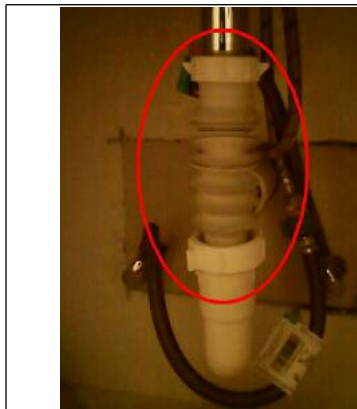
Comments Recommend caulking/grouting in shower/tub area
 Drains show no signs of back-up during time of inspection.
 Outlets were randomly tested and had correct polarity.
 Handyman style plumbing work, no leaks.
 Water temperature was 131

Handyman work

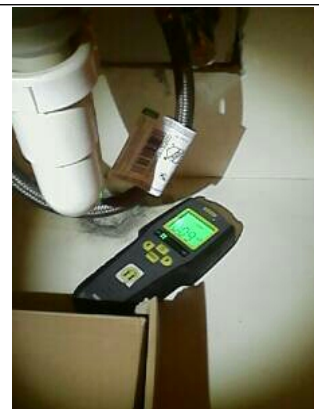
Water stain under sink, dry now

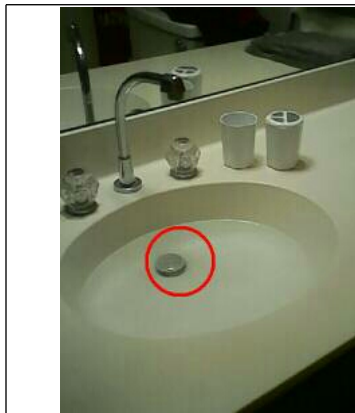
Comments Sink drain shows sign of back-up, recommend repair.
 Moisture stains present under sink with high moisture content. Recommend repair \ replace or at least monitor.
 Outlets were randomly tested and had correct polarity.
 Water temperature was 118.

Slow to drain

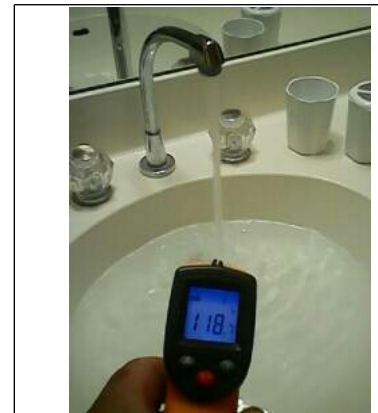
Water temp 118

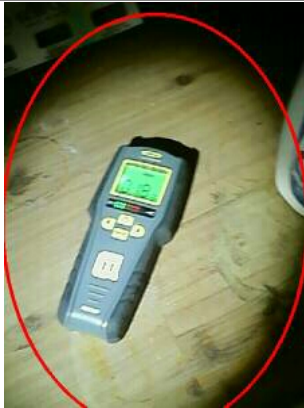
Cabinet high moisture content

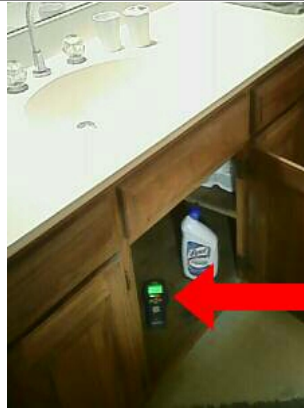
High moisture

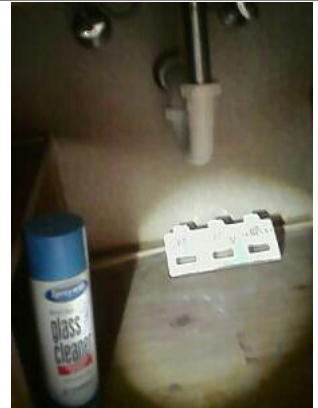
Pest control box, ask sellers about insects

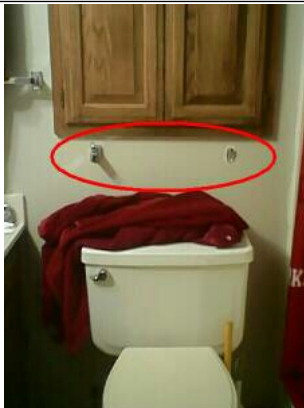
Towel rack broken

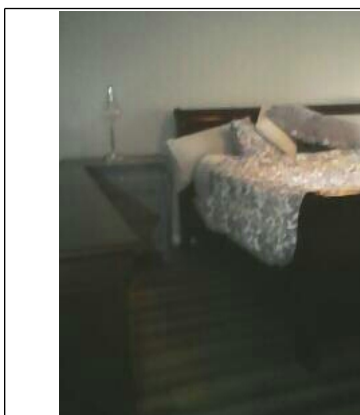
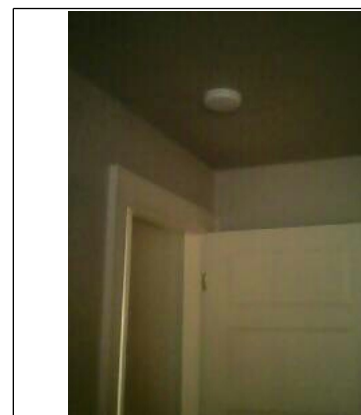
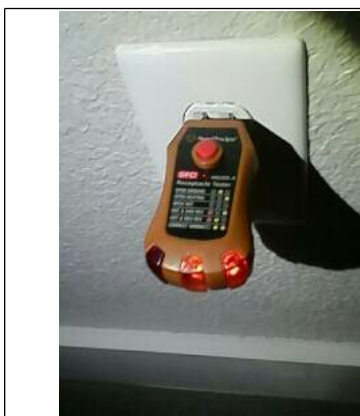
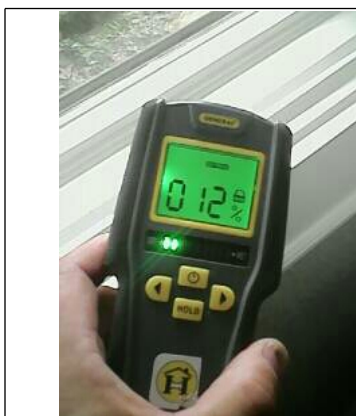
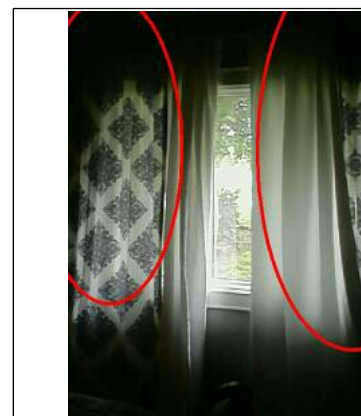
Comments No window screens.

No screens

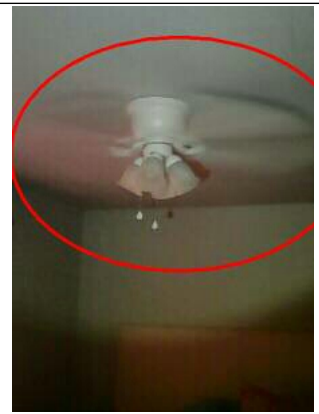
Comments Ceiling fan is wobbling, recommend repair.
No window screen(s)

Fan wobbles

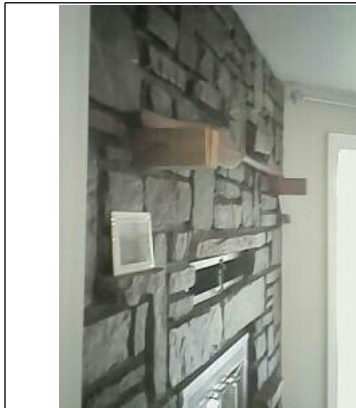
Mantel missing

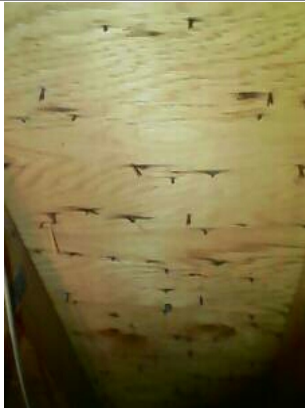
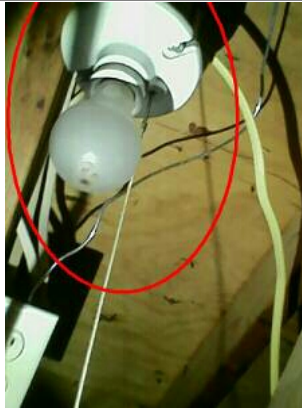
No cover

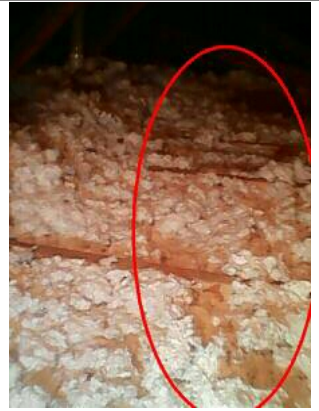
Insulation ☐ Fiberglass ☐ Batts ☒ Loose ☐ Cellulose ☐ Foam ☐ Other ☐ Vermiculite ☐ Rock wool
 Depth: 4-13 inches ☐ Damaged ☒ Displaced ☐ Missing ☒ Compressed
☒ Recommend additional insulation

Compressed insulation

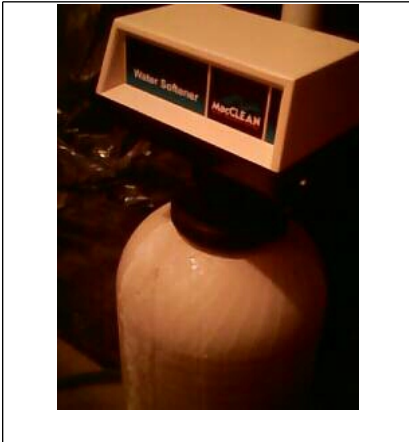
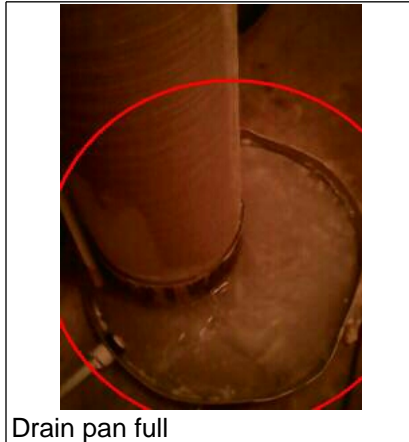
Drain pan full

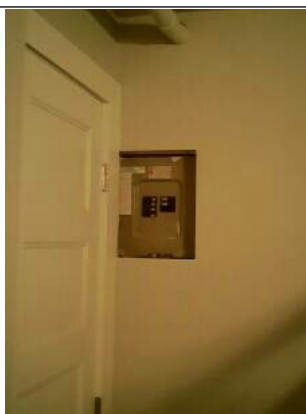
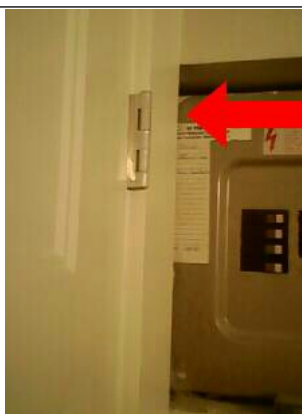
Panel blocked.

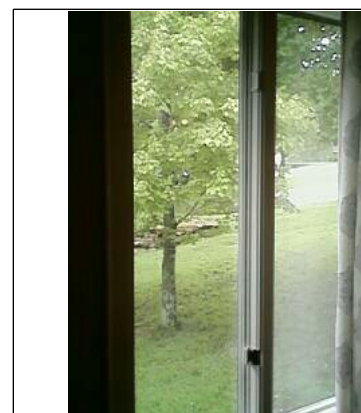
No screens

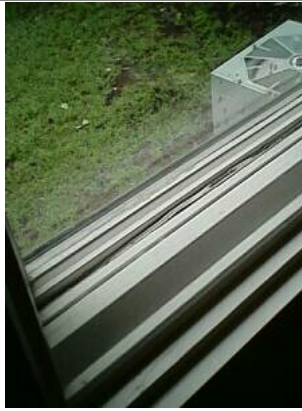
Weather stripping damaged
